BOILER TUBE ANALYSIS

**BY
S.V RAJU**

AT ASSALAYA —SUDAN

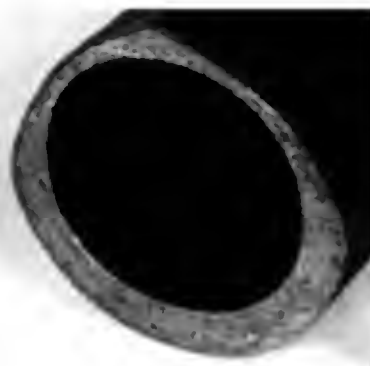
13.Erosion .

Symptoms: Tube experiences metal loss from the OD of the tube. Damage will be oriented on the impact side of the tube. Ultimate failure results from rupture due to increasing strain as tube material erodes away. **Causes:** Erosion of tube surfaces occurs from impingement on the external surfaces. The erosion medium can be any abrasive in the combustion gas flow stream, but most commonly is associated with impingement of fly

ash or soot blowing steam. In cases where soot blower steam is the primary cause, the erosion may be accompanied by thermal fatigue.
